CHANGE SUMMARY - MULTIPOSITION MICROELECTRIC ACTUATOR CONTROLLER

Technical Note 434

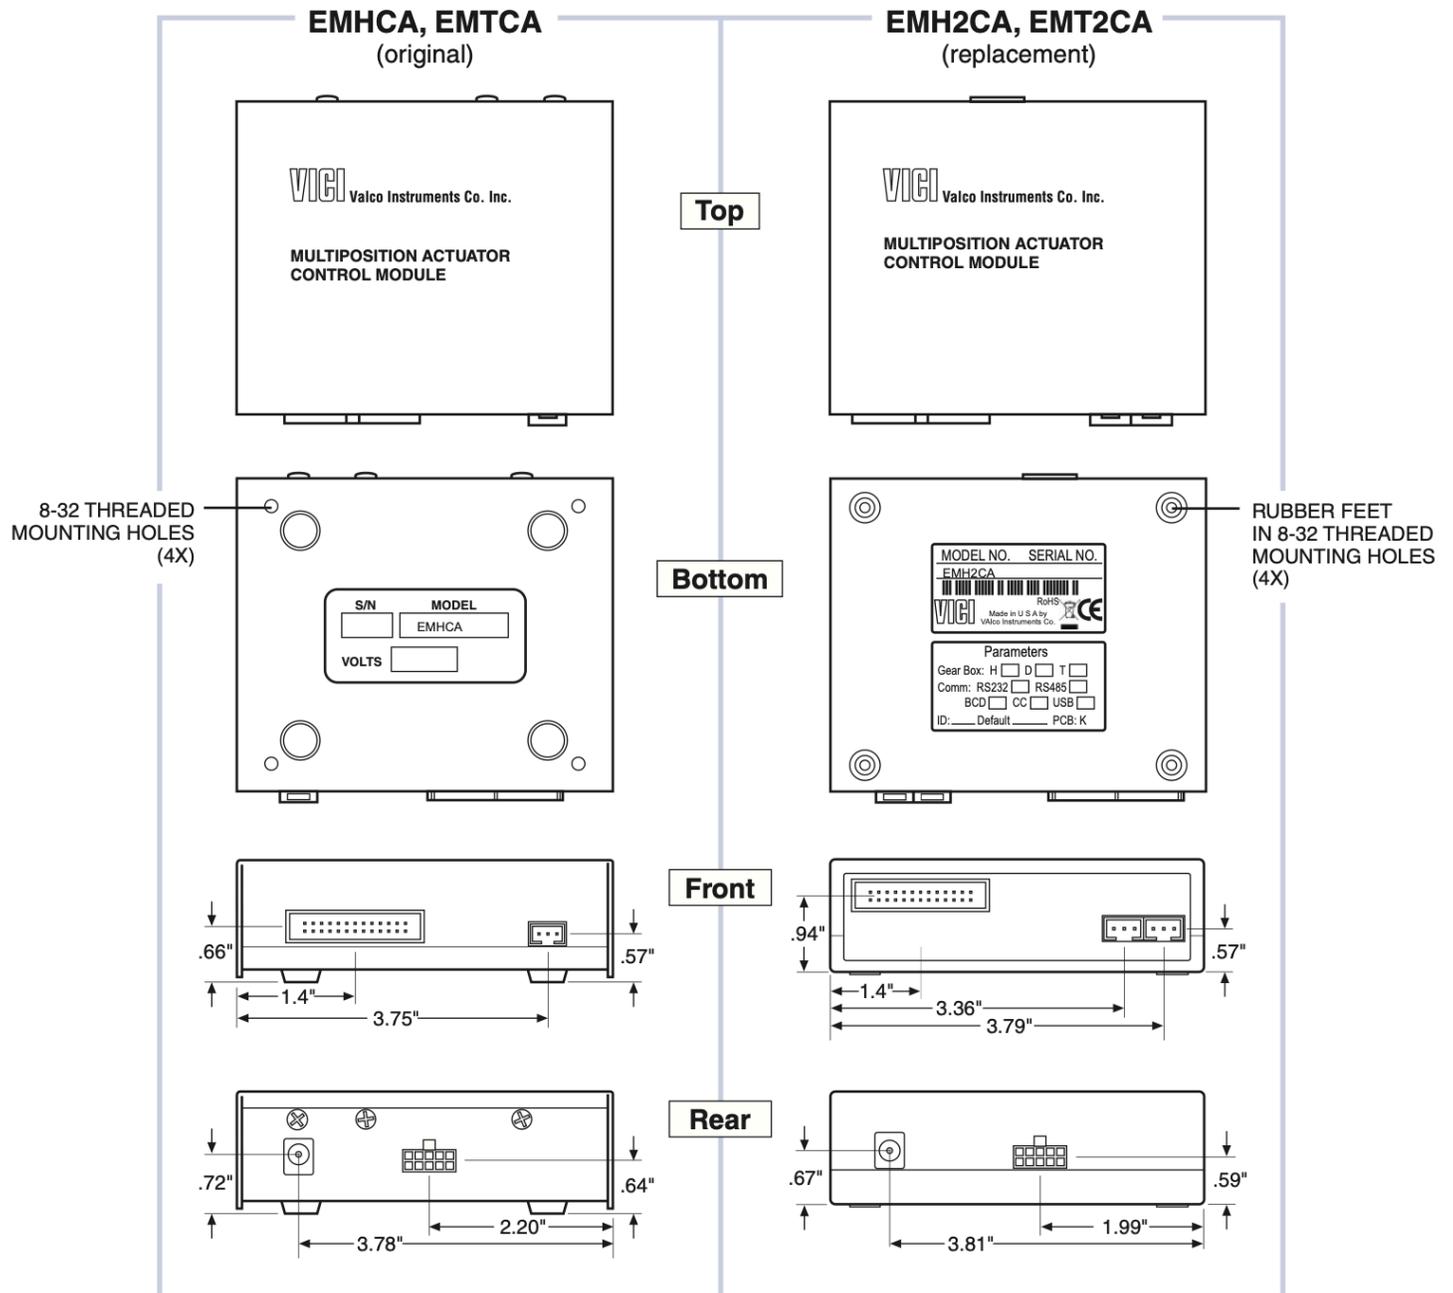
- The replacement controller is identical in function and is backwards-compatible.
- The exterior dimensions and mounting hole locations do not change.
- Power and communications ports are in nearly identical locations, but have moved a fraction of an inch.

Figure 1: Visual and dimensional differences between the original controller (left) and the replacement controller (right)
